MISCELLANEOUS PAPER SL-80-10

CONSTRUCTION OF TREMIE CONCRETE CUTOFF WALL, WOLF CREEK DAM, KENTUCKY

Structures Laboratory
U. S. Army Engineer Waterways Experiment Station
P. O. Box 631, Vicksburg, Miss. 39180

September 1980

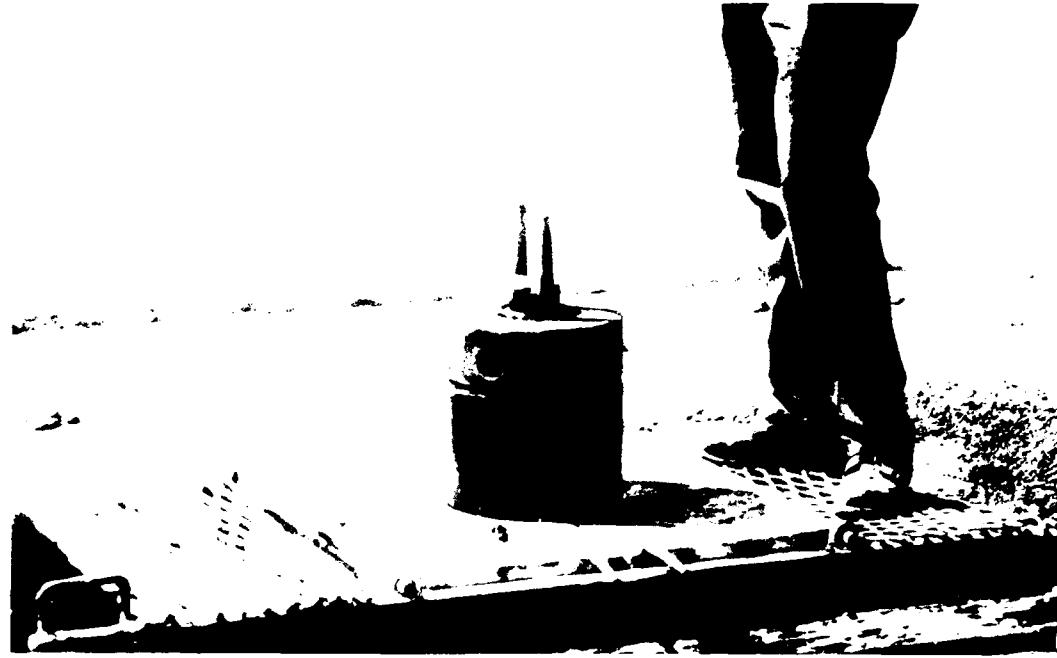
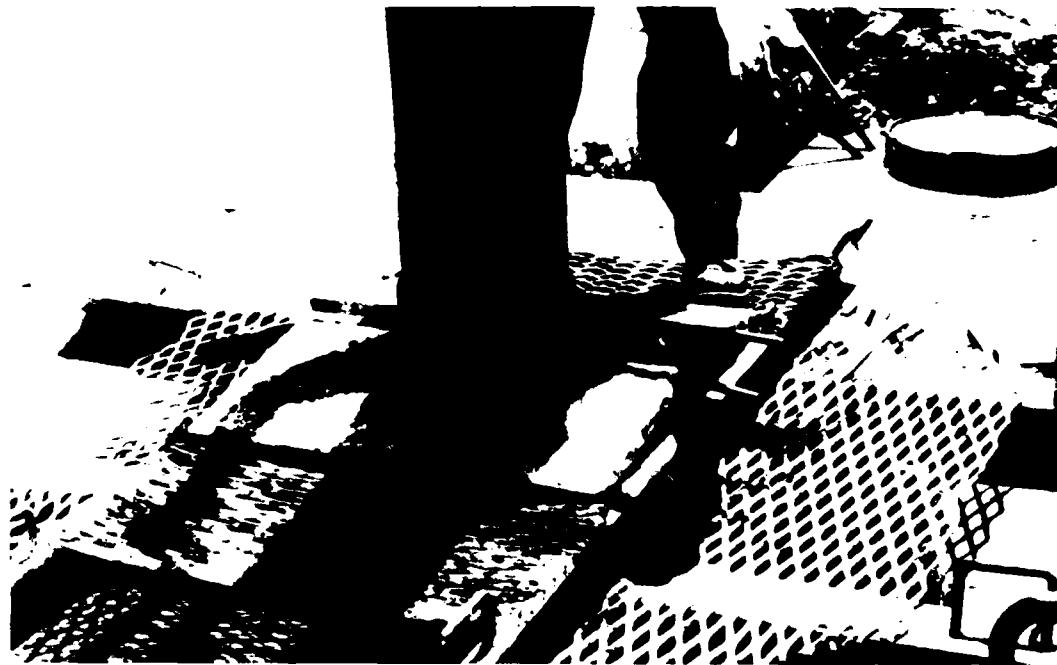
Figure 9. Tremie support scheme

a. Tremie pipe supported by coupling. Loop is used to raise tremie as sections are removed

b. Tremie pipe being raised (note how support plates open to allow passage of couplings)

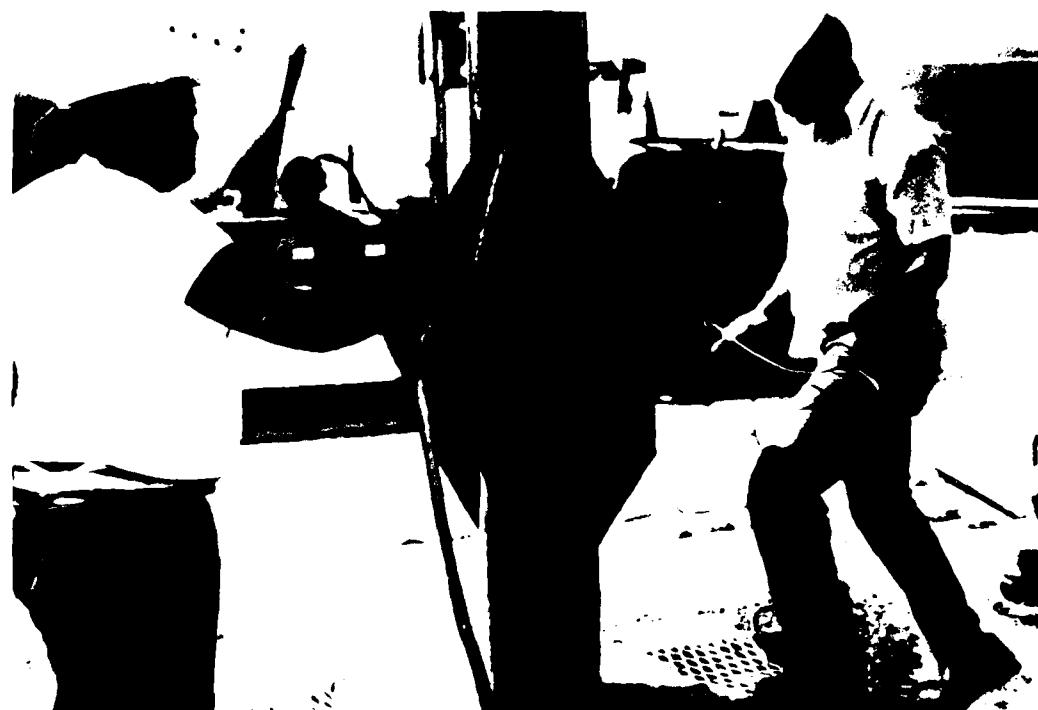
Figure 16. Fins added to tremie pipe
to ensure proper centering

33. Another potential problem area was the centering of the tremie in the holes--particularly the primary elements. If the pipe were not centered, there was a possibility of inhibiting the flow of the concrete as it left the tremie mouth. To eliminate this possibility, centering fins were added to the section of the tremie pipe above the mouth (Figure 16). While this modification did ensure proper centering of the tremie pipe, it raised the question of inhibiting the return of the wooden sphere described above. Cores taken after addition of the fins continued to show anomalies, indicating that the fins had not resolved the overall problem.
